PHYSICAL SAFETY DESIGN ASSESSMENT

Windsor Public Library – Main Branch: 850 Ouellette Avenue – Windsor, Ontario

Prepared by: Barry Horrobin, Director of Planning & Physical Resources
WINDSOR POLICE SERVICE

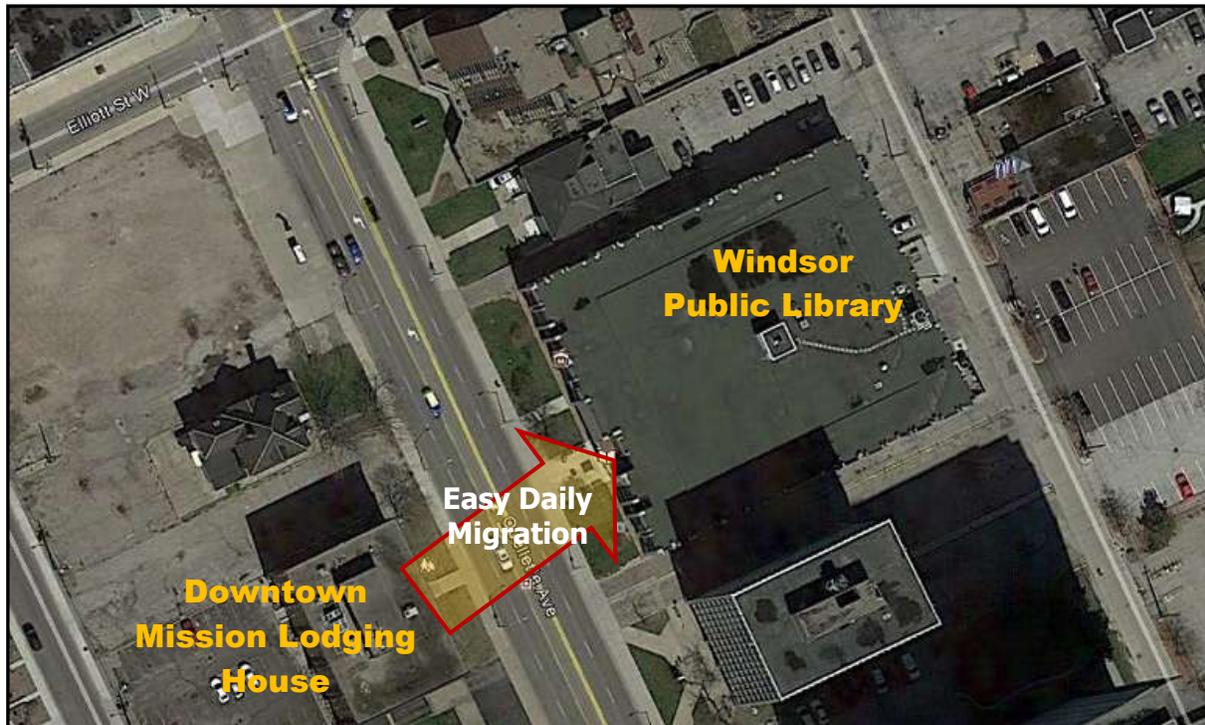
Library's physical location is attractively close to larger transient populations, making for a unique challenge to maintain safety and public order

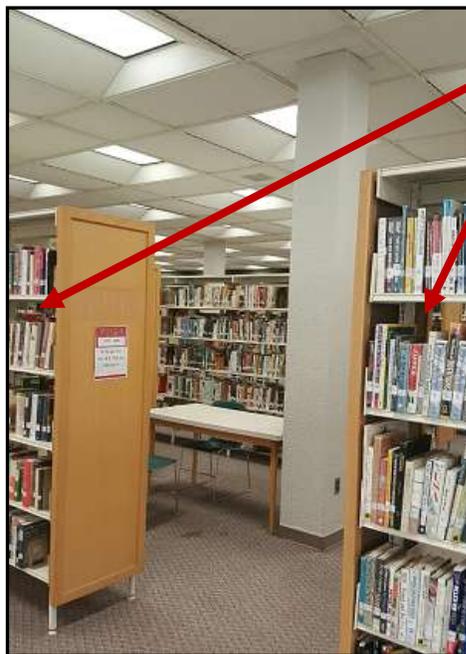
2. The design of the book shelves plays a critical role in maintaining an adequate degree of observation capability on an ongoing basis. This is particularly important in a large library facility such as this where there are numerous pockets of discreet space that make it easy to loiter. The majority of shelving units are tall (7' high) and while there are some spaces to permit a degree of visibility, the proportion of the shelf occupied by books takes up most of the space, thus limiting sight lines. A prototype shorter shelving unit has been developed and while these are much shorter (4'-5') to allow better visibility over the top, there are no spaces on the shelves due to a solid backing. This creates sight line loss.

Open Shelf permits some visibility

Opaque = no view corridor

RECOMMENDATION: Consider modification of the prototype shelf unit that has the lower height but with adequate space in each shelf to avoid an opaque backing in order to allow sight lines to be maintained.

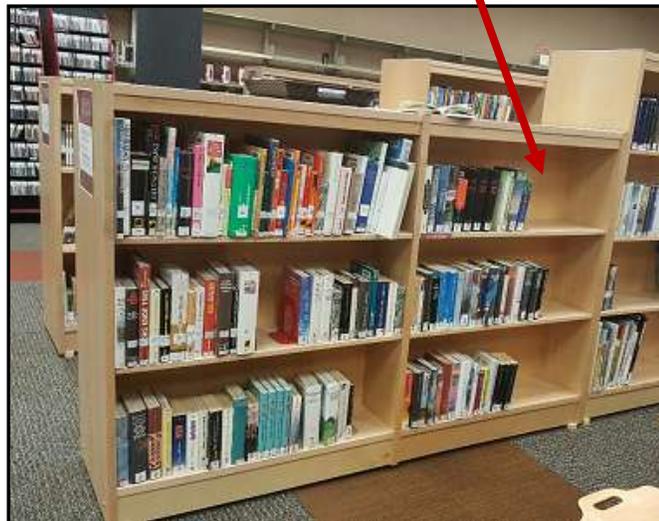
Book shelf spacing is critical in order to be able to maintain some element of monitoring of spaces in between

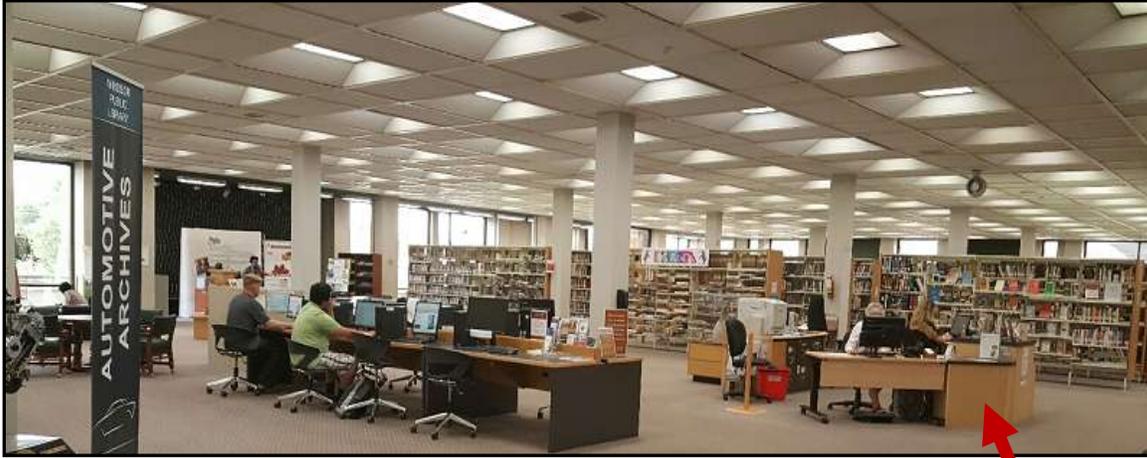
3. The staff desk on the second floor is poorly oriented for being able to effectively monitor activity within the immediate area. All employees are essentially facing the same direction, leaving many blind spots where problems can arise without detection.
- RECOMMENDATION:** The furniture in this work area should be adjusted to enable staff to be oriented in different directions to optimize surveillance capability.

Current staff desks are only able to see a limited amount of the surrounding space

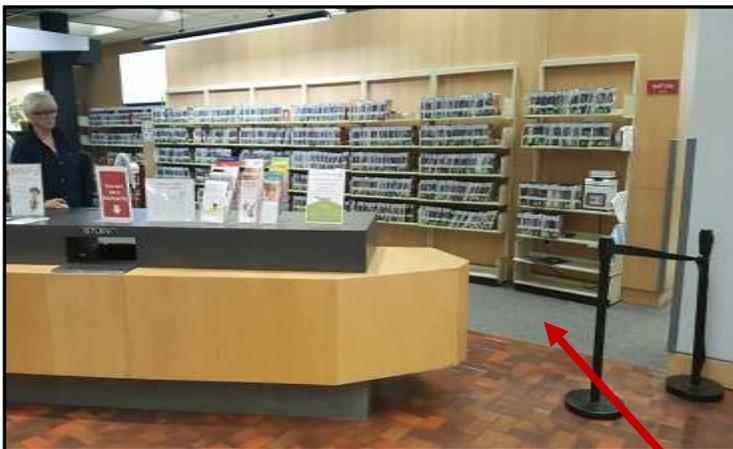
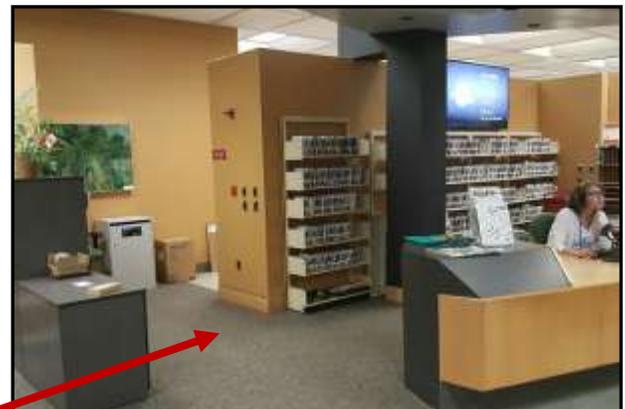
4. The main floor reception desk is nicely oriented to face the building entrance but its physical configuration creates vulnerability for employees due to its low counter height (just 38”) and depth of just 24” in some locations, elevating risk to confrontations. It also has openings on both ends where anyone can easily gain access. There is a need to strengthen this work area to make it more secure.

Large openings at sides of main reception desk need to be closed in with gates

RECOMMENDATION: This desk needs to be closed in on both ends using lockable gates to help prevent unauthorized access. It would also be advisable to make architectural modifications to the counter to raise its overall height and/or increase its depth as either change will improve the “non-confrontational” strength of it, providing added safety for employees when dealing with individuals exhibiting harsh behaviour.

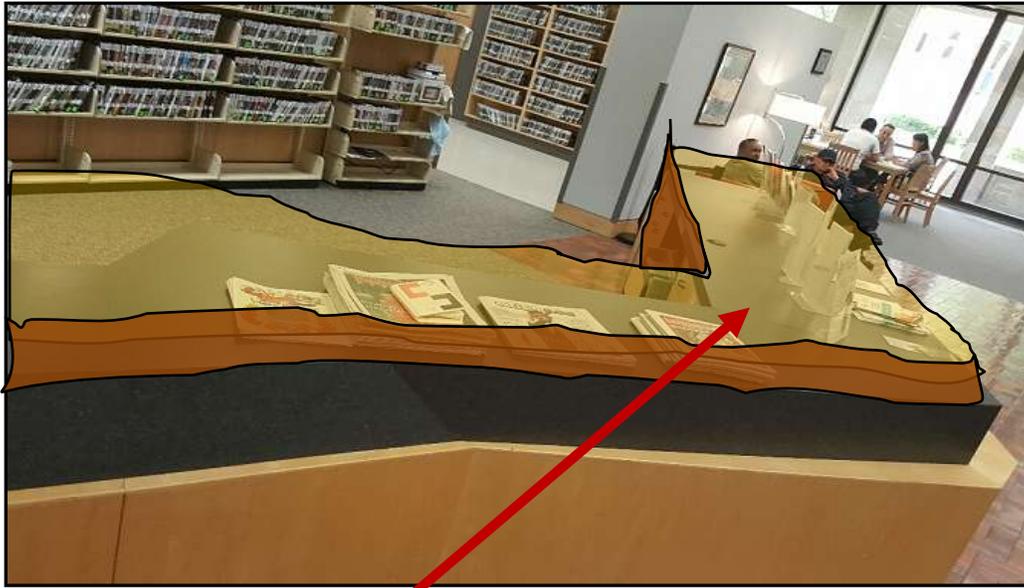
Consideration should be made to modify the main reception desk by adding additional millwork to it that will increase height and depth

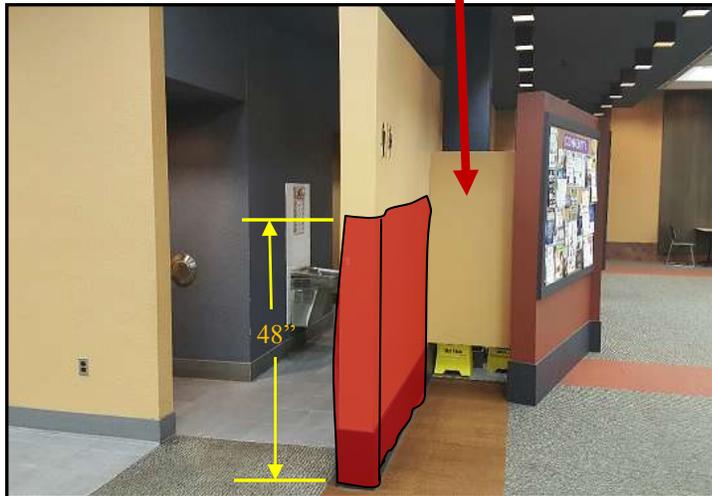
5. The public washrooms on the main floor, second floor, and basement levels, for different reasons, all carry some degree of elevated vulnerability. In the case of the first floor washrooms, the architectural screening wall creates added discretion which can trigger inappropriate behaviour. In this regard, the wall provides an area of concealment, blocking sight lines so that staff, security officers, and other patrons cannot naturally monitor activity in and out of the washrooms. The washrooms on the second floor represent a design that is completely opposite to known safe design standards. They are discretely positioned in an alcove-type corridor, away from general traffic areas. This creates an environment that is attractive for unlawful and undesirable behaviour to establish and sustain itself. The washrooms in the basement level are vulnerable simply because they are situated within a low traffic area of the building, elevating vulnerability to problematic behaviour.

Remove partition to prevent loitering

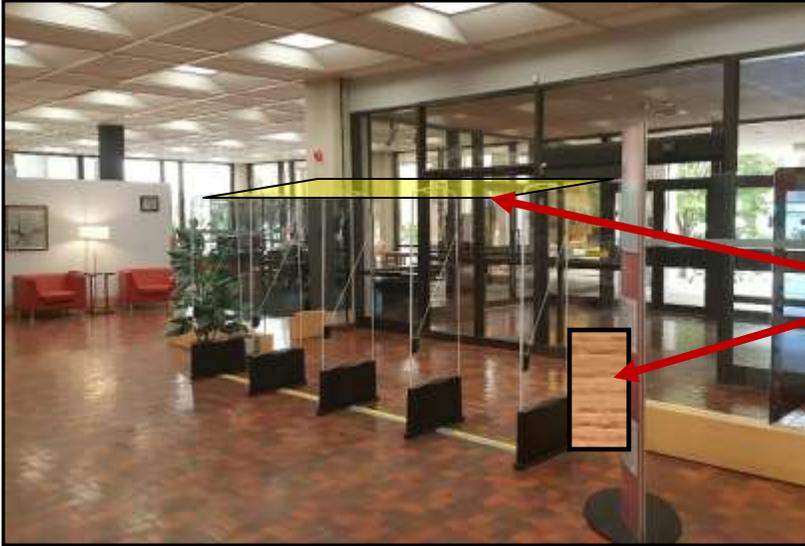
7. The “book alarm” system at the exits of both the front and rear access points is largely effective but has one major shortfall. The design is such that a person attempting to exit the library without having properly checked out a book can easily do so without triggering the alarm simply by raising the book over the height of the detection threshold or walking around and through existing gaps. This creates a situation where there can be undocumented losses of inventory on a regular basis.
Recommendation: It may be that lost products have not been an issue but the risk exists nonetheless. The simplest solution for corrective action

Book alarm design does not properly “seal” off ability for a person to discreetly exit without properly checking out items. Need to install millwork extension to close off opening and acrylic top to prevent lifting items up over the detection panels.

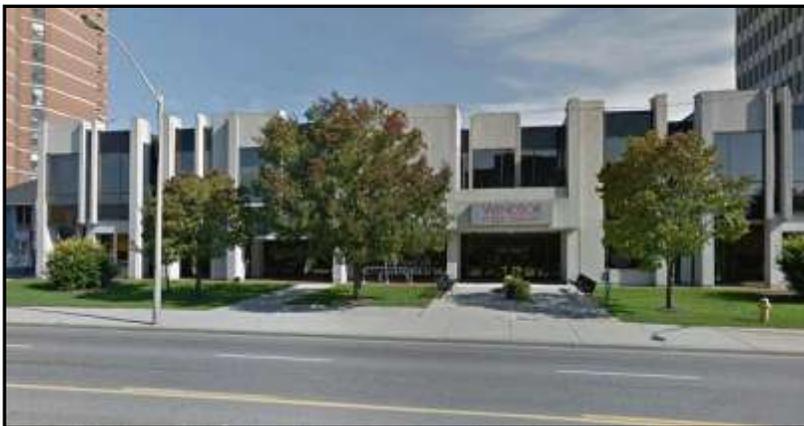
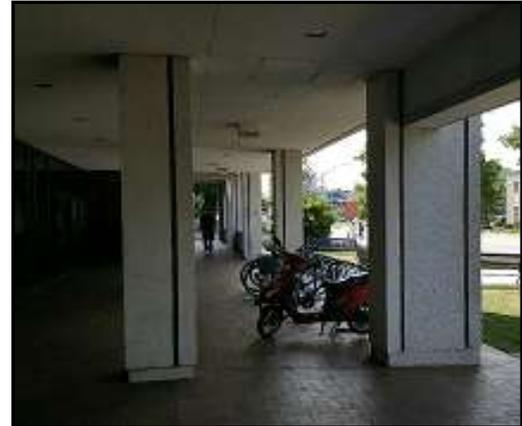
8. The main entrance area and general front façade of the building is dark and shrouded, facilitating loitering and other behaviour that is difficult to observe and report on an ongoing basis. The bicycle rack in this area places bicycles at elevated risk of theft because visibility is marginalized. Ongoing visibility of this area needs to increase.
Recommendation: LED lights should be added in this area to increase overall visibility. The recommended minimum illumination level is 4.5 foot-candles.

Covered front of building creates a darkened zone that minimizes visibility

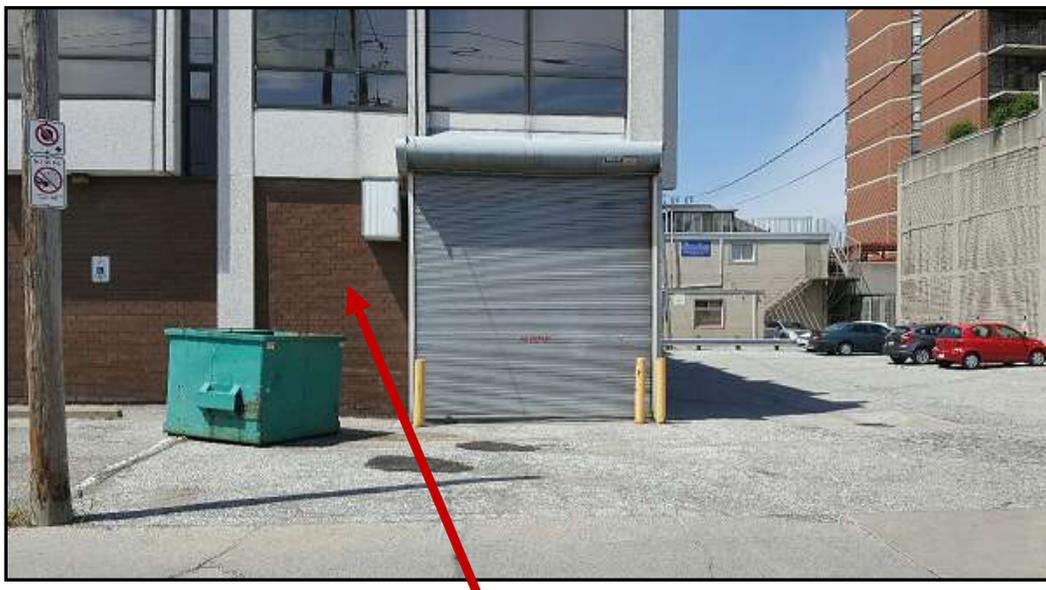
10. The large refuse dumpster at the rear of the building is placed in such a way that it creates an opportunity for loitering and other undesirable behaviour to take place. Furthermore, it does not have an enclosure around it which is the City standard. **Recommendation:** A proper enclosure should be provided with the dumpster placed within it. This enclosure should be placed against the back wall to remove any discreet spaces to hide/loiter.

Construct proper refuse enclosure (per City standard) and place against wall here
